2nd Field Survey Report for Palu Tsunami 2018

Taro Arikawa¹, Abdul Muhari², Yoshihiro Okumura³, Yuji Dohi⁴, Bagus Afriyanto²,
Karina Aprilia Sujatmiko⁵

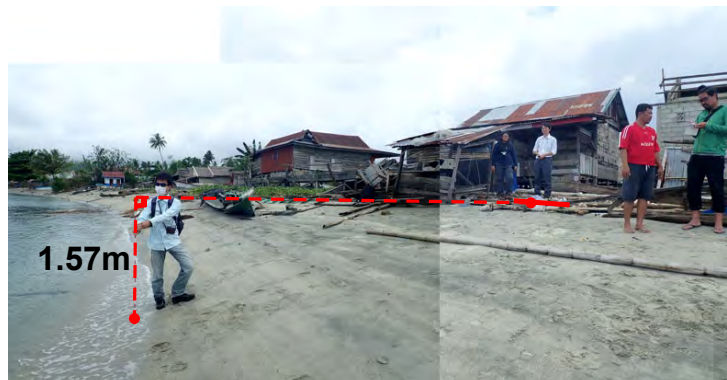
ID1

Tsunami Height and Behavior at Point A

- Run up height is 1.57m
- After the earthquake, the sea level fell down and seemed to hit in the offing, after that the tsunami headed for the shore

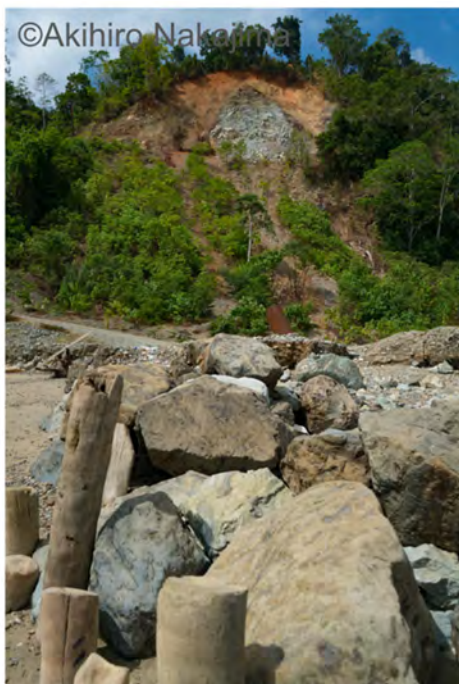
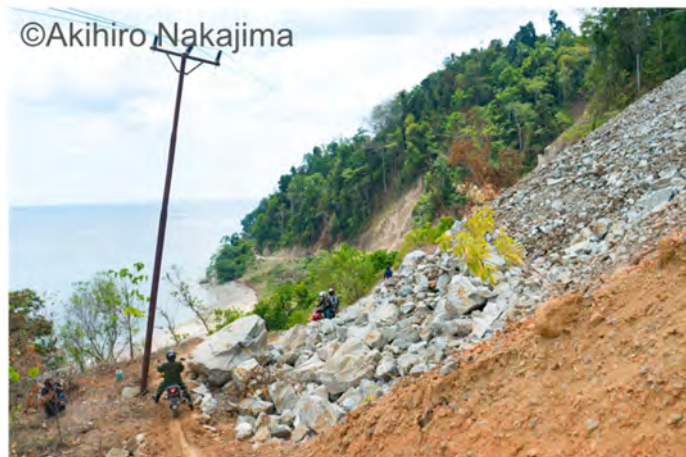
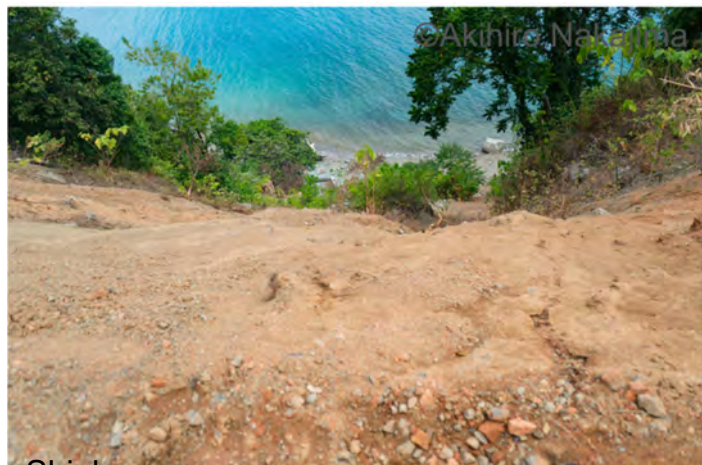
State of Landslide at Point B

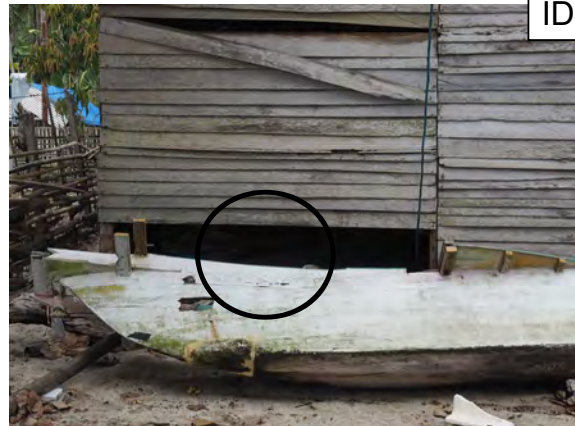
ID2

The height of the tsunami around the point B

There was no water marks inside a wooden building.
 At least, a tsunami height is lower than the upper of the concrete block of the foundation.

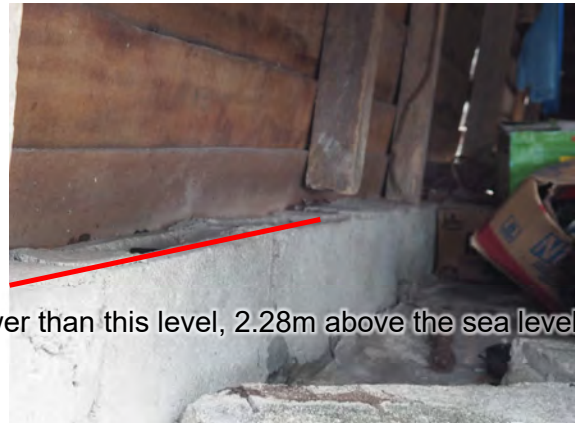
ID3

Lower than this level, 2.28m above the sea level

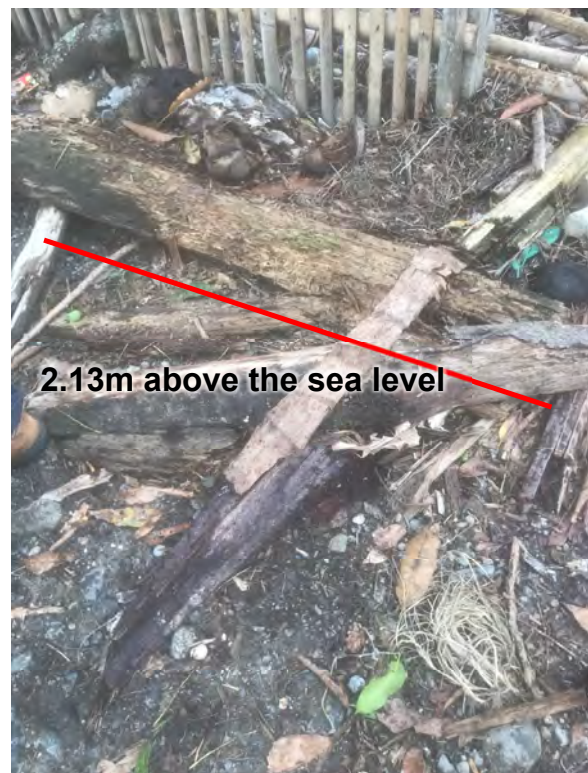
2.13m above the sea level

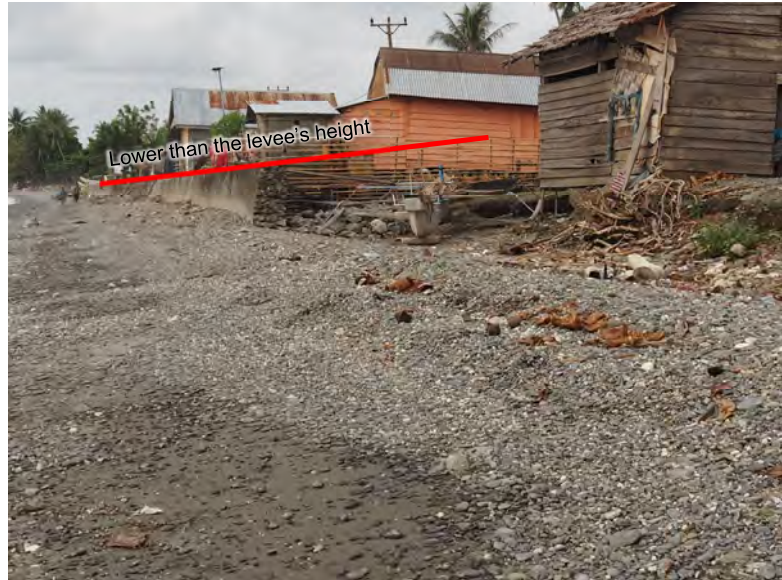
More information...

The slope seen at the coast can be considered to be the subsidence?

This subsidence indicates the possibility of the tsunami source resulted from the land slide under the sea?

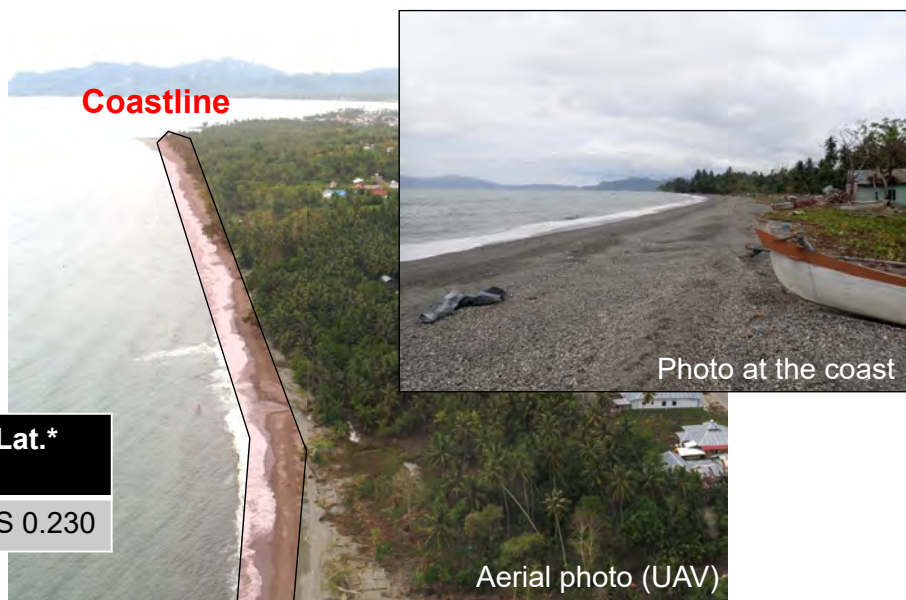
Aerial photo (UAV)

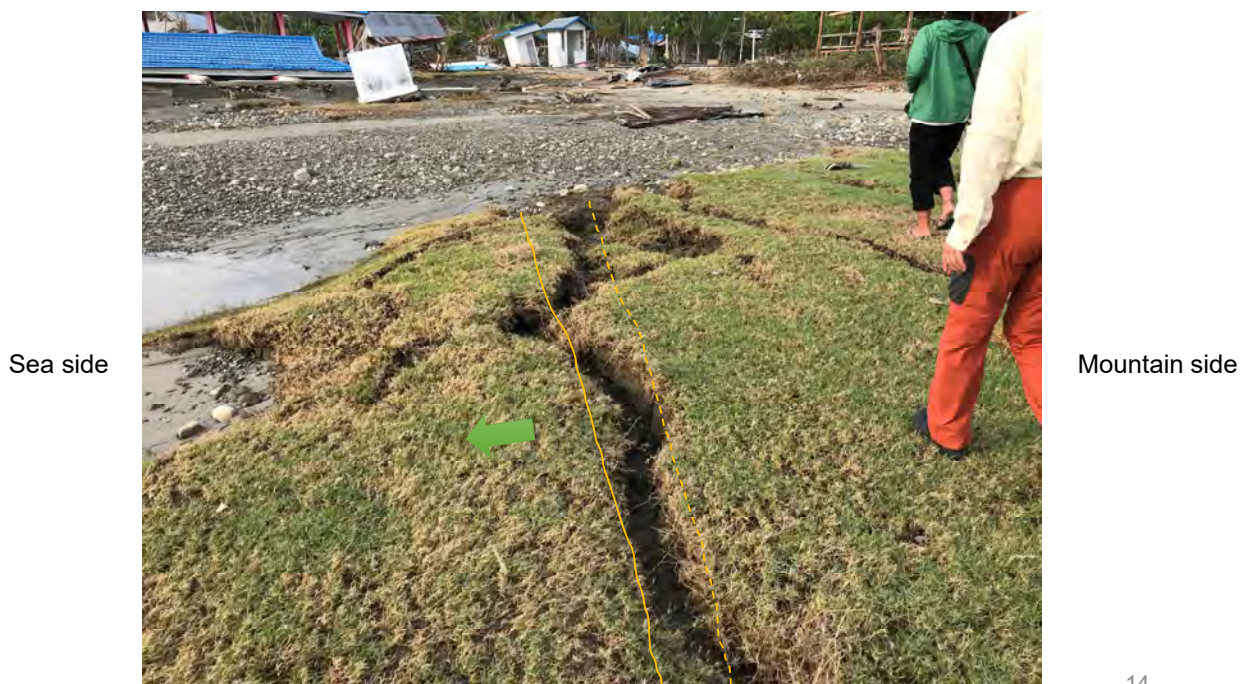
ID14

Scene of crack at point C

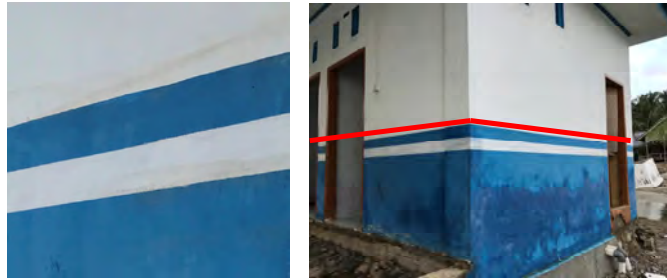
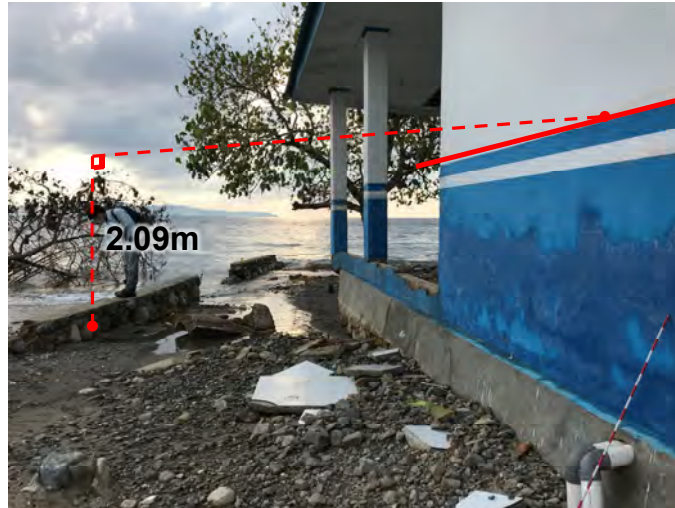
Tsunami Height at Point C

At least 3.01m height of tsunami arrived at this area because of a floating wooden building. Flow depth is 2.09m here.

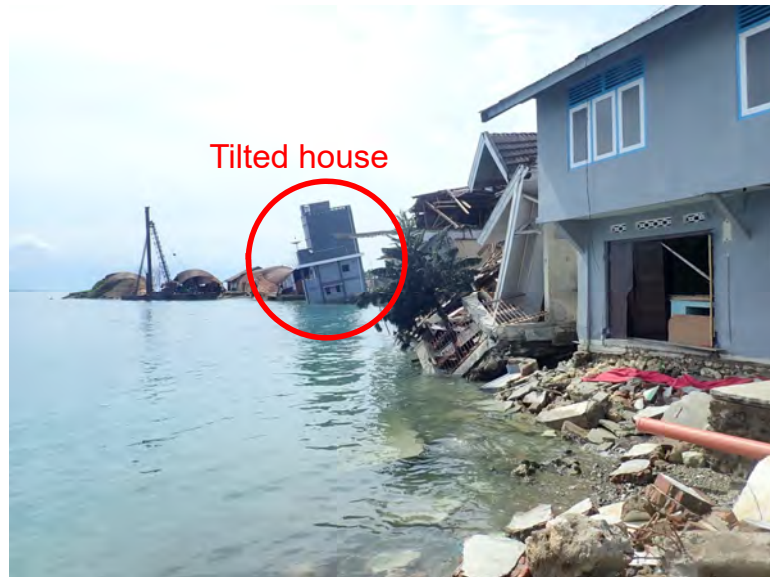
Point D

The tilted house can be seen.

Additionally, some houses sank into the sea after the earthquake, base on the testimony by the diver who dived into the sea around here on the day after the earthquake.

These phenomena indicates the possibility of the submarine landslides here.

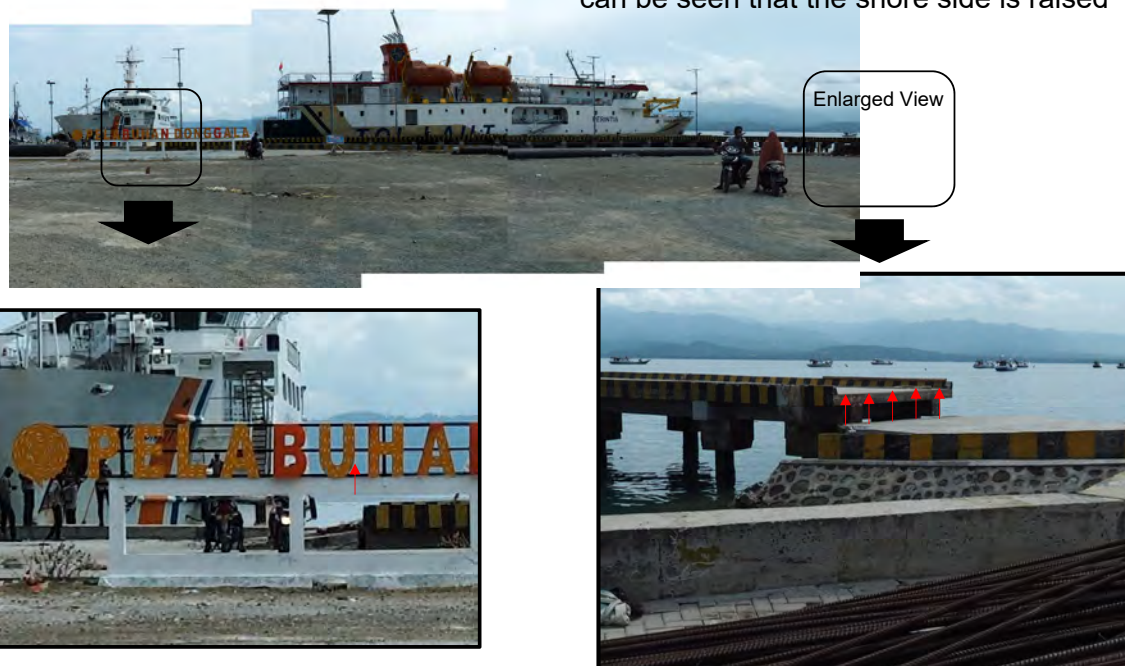
ID6

Scene of step at the pier due to subsidence of the ground at point D

Due to the bottom of the offshore side of the pile of the pier might be subsidence, it can be seen that the shore side is raised

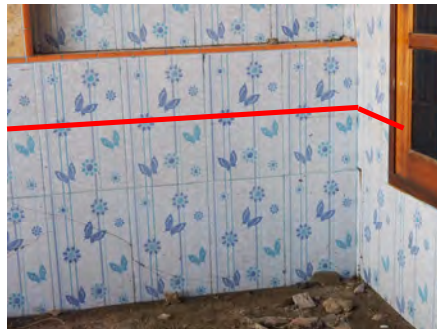
Tsunami Height and Behavior near by Point D

- There was no evidence of the subsidence here.
- The tsunami arrived in 10 minutes after the earthquake

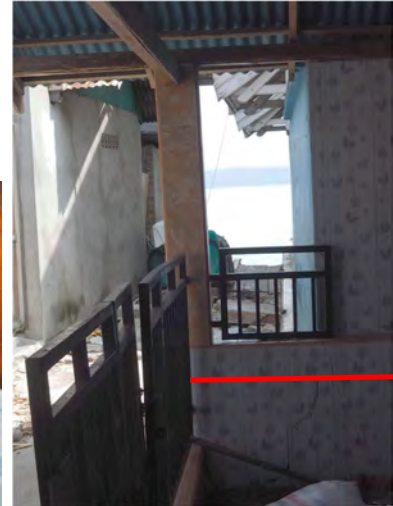
Tsunami Height and Behavior at Point D

- Inundation height is 1.67m
- Because the sea overflowed soon after the earthquake, they ran away to the hill. On the way to the evacuation, they saw tsunami inundated in the river.

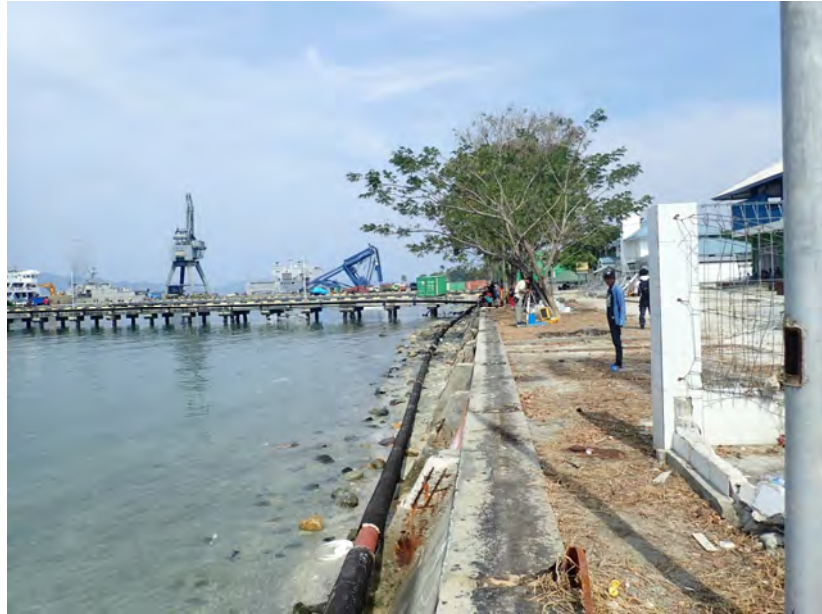
Point E

At the Pantoloan Port, the settlement could not be seen from the land. On the other hand, in Wani 2 village just to the north of it, there was a possibility of the subsidence (see the result of the first survey)

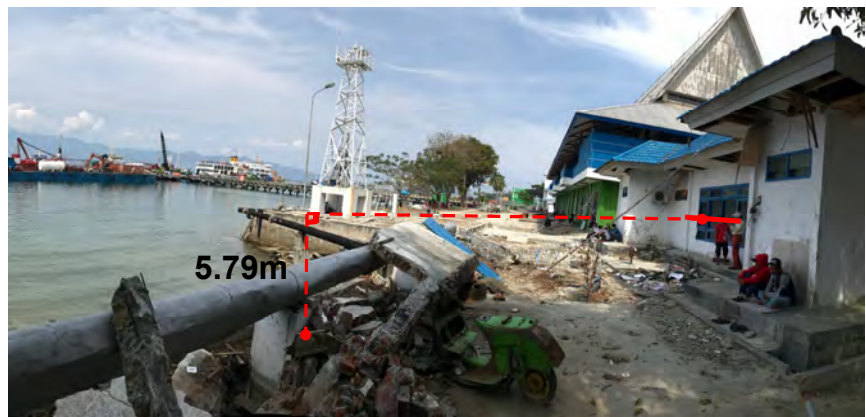
ID15

Tsunami Height at Point E

Splash

Unbroken window glass

Broken window glass

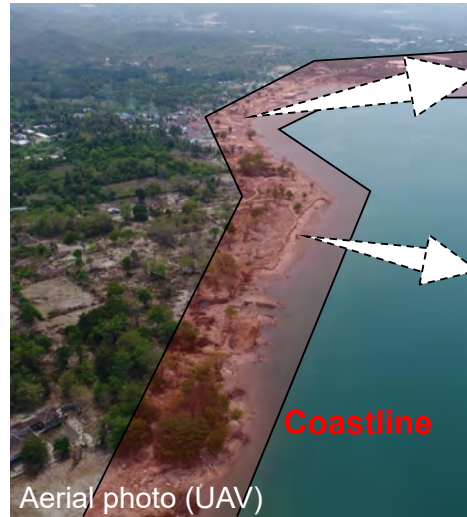
Point F

The area around here seems to have subsided entirely. A comparison by Google Earth is also shown in the subsequent slides. On the other hand, the possibility that there was a step on the sand beach before the earthquake occurred can not be denied

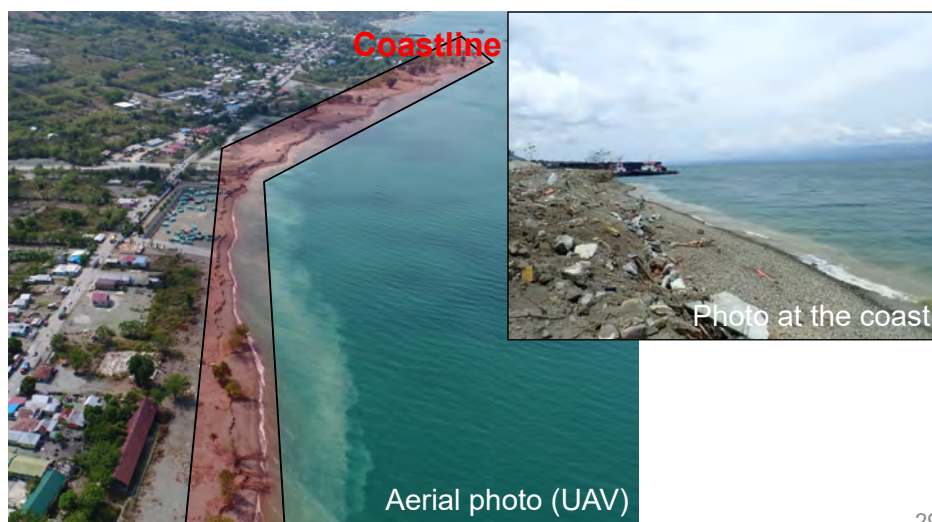
Point G

The steep slope seen at the coast can be considered to be the subsidence. Additionally, change in the color at the sea surface near the coastline can be seen. These phenomena indicates the possibility of the tsunami source resulted from the land slide under the sea.

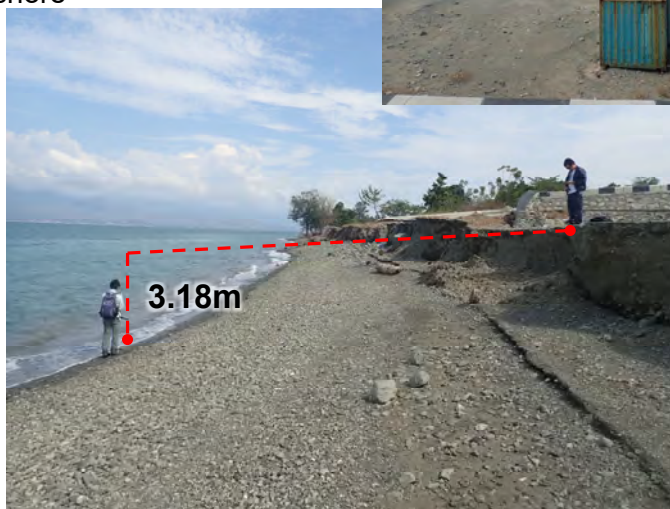
ID12

Subsidence and Tsunami behavior at Point G

- There were drifted containers on the ground 3.18m from the sea level.
- Container yard disappeared about 100 meters in the cross-shore direction

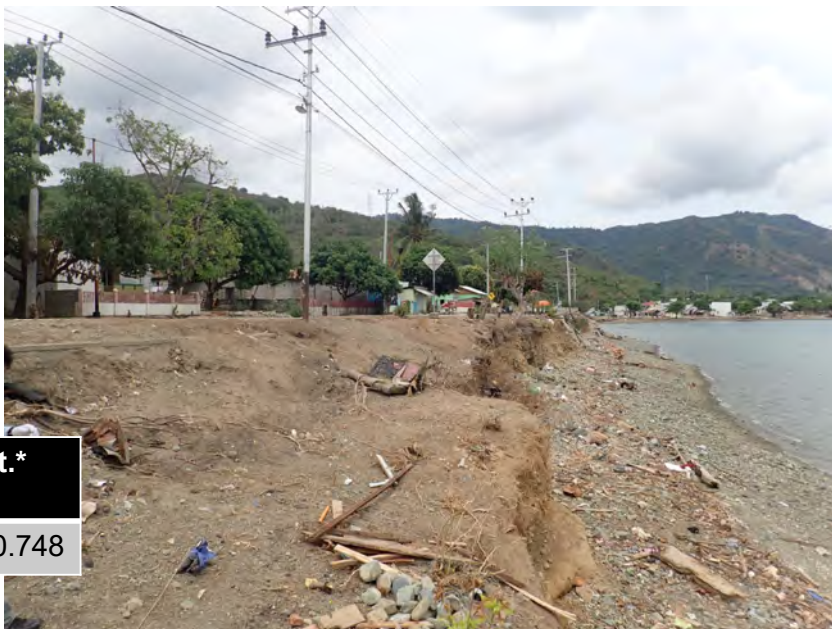
The small cliff was seen at the coast of north part of Point G. It resulted from the subsidence by **1968 earthquake** based on the testimony by the inhabitant. It indicates that the earthquakes repeatedly occur in this region.

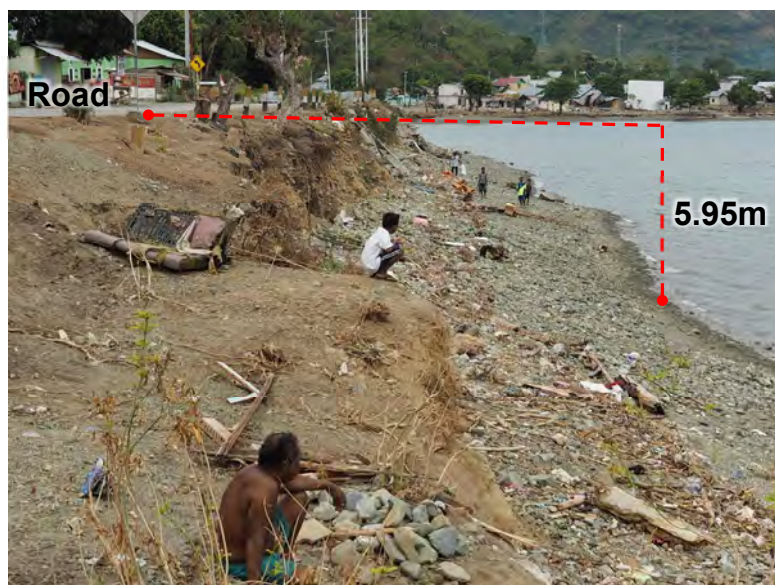
ID8

Tsunami height

A tsunami overflowed the road.

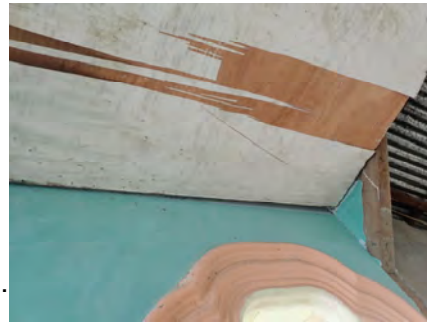
Tsunami height

Splash mark on the ceiling.
The height of the mark above the sea level is 8.51m.

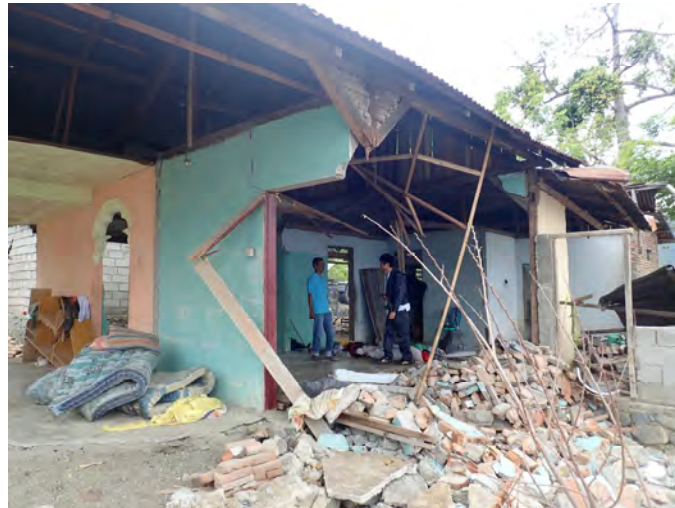
Tsunami height

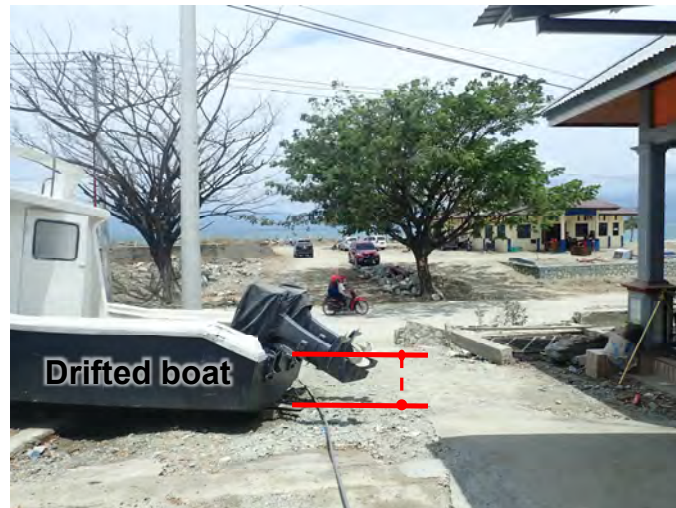
- Flow depth was a knee level at the place of the drifted boat.
- Inundation height was 5.25m
